**TOWN OF STAMFORD**  
**ZONING BOARD OF ADJUSTMENT MEETING**  
**June 25, 2025**  
**(UNAPPROVED)**

PREPARED EXCLUSIVELY FOR:  
Lori Shepard

INSPECTED ON:  
Saturday, October 26, 2024

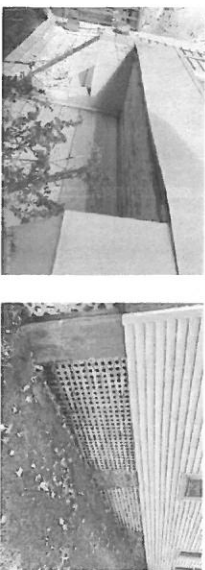
**75:** There was peeling paint in one or more locations. We recommend this area be prepared and refinished.

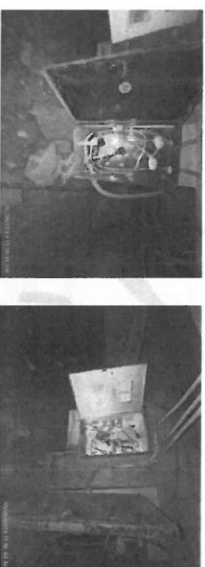
**245:** Bad box choice

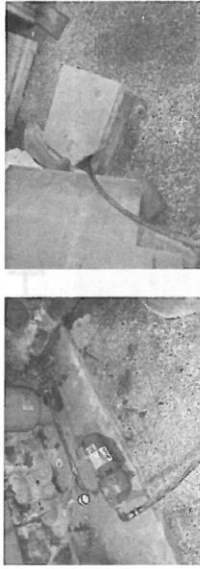
- 258:** All aspects of the well and related equipment were not inspected in detail. Detailed testing of the operation, integrity, and control functions for this system is beyond the scope of this inspection. For detailed inspection and maintenance we would recommend the advice of a well and/or well treatment contractor.

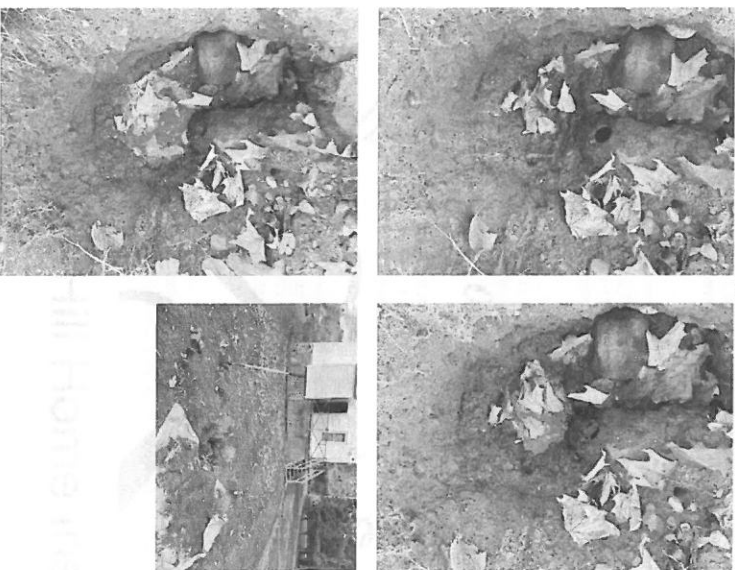
331: It appears no leaching system was present. We observed a cast iron pipe discharging directly into the soil of filled with soil from the opening in the inlet line, at the depression in the yard. This is a substandard installation. We would recommend review by a licensed designer and repair/replace as needed.
