**TOWN OF STAMFORD**  
**ZONING BOARD OF ADJUSTMENT MEETING**  
**June 25, 2025**  
**(UNAPPROVED)**

PREPARED EXCLUSIVELY FOR:  
Lori Shepard

INSPECTED ON:  
Saturday, October 26, 2024

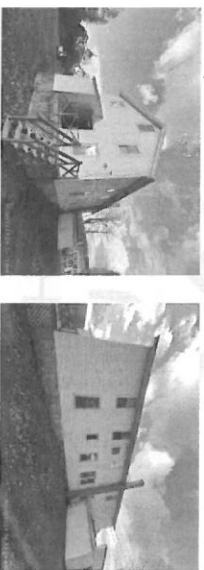
**78:** There were areas where exterior features are in need of attention. These conditions suggest lapses in maintenance. We make no attempt to list all cosmetic flaws but, do suggest attention to items relating to function and safety.

**77:** As preventive maintenance, caulking and sealing the gaps in the exterior of the building around the doors, windows, plumbing and electrical entry points will help prevent heat loss, cold air infiltration and moisture entry. If caulking is needed for maintenance of any flashing or exterior trim, we suggest a high quality urethane sealant such as Sikaflex<sup>®</sup>. Latex, butyl, oil based, silicone or architectural grade sealants should be avoided.

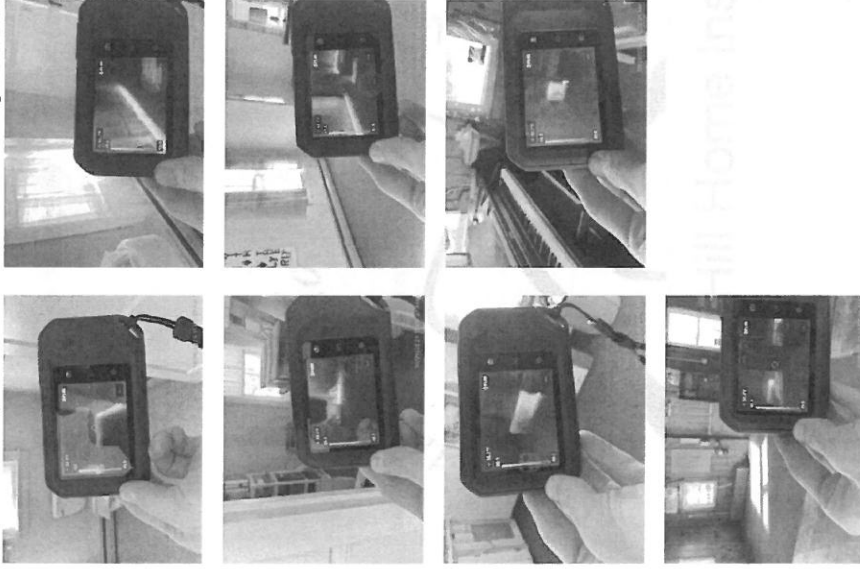
**173:** We observed a permanent heat source in each room throughout the building.

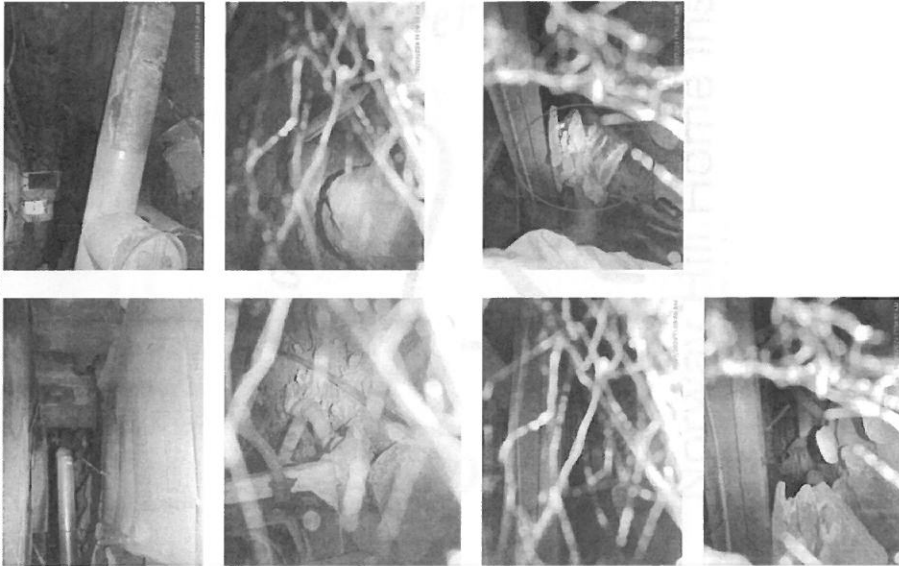
**249:** All of the structural elements appear to be performing as would be expected for a building of this age and type. However, we direct your attention to the items noted above.
